The Port of Callao

South America's Most Modern Port in the Making

JUNE 1953

Background and Present Situation in the Port of Callao

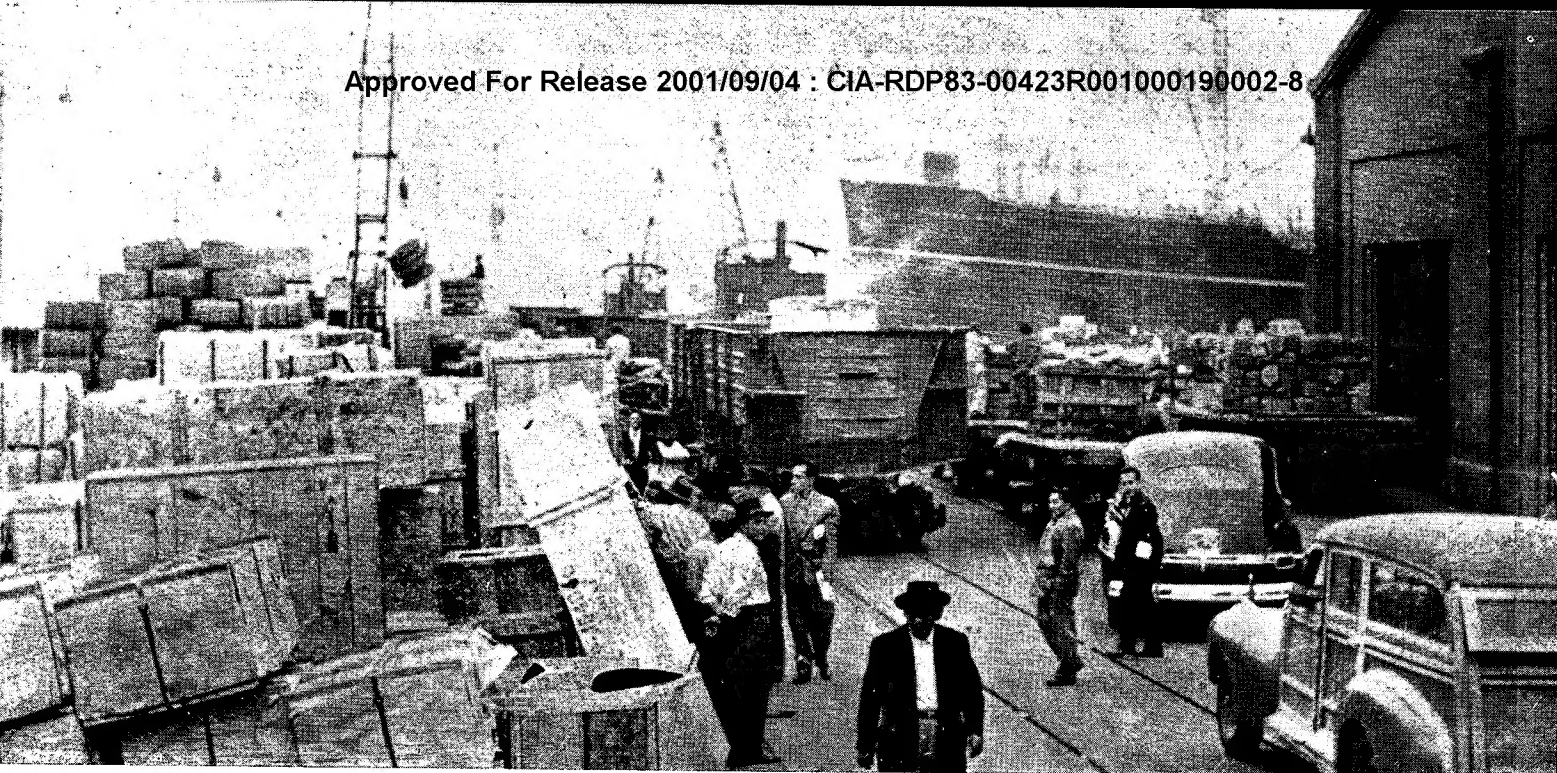
Before: Scene in front of the main piers, showing general confusion, congestion and lack of traffic control, Sept. 1, 1951.

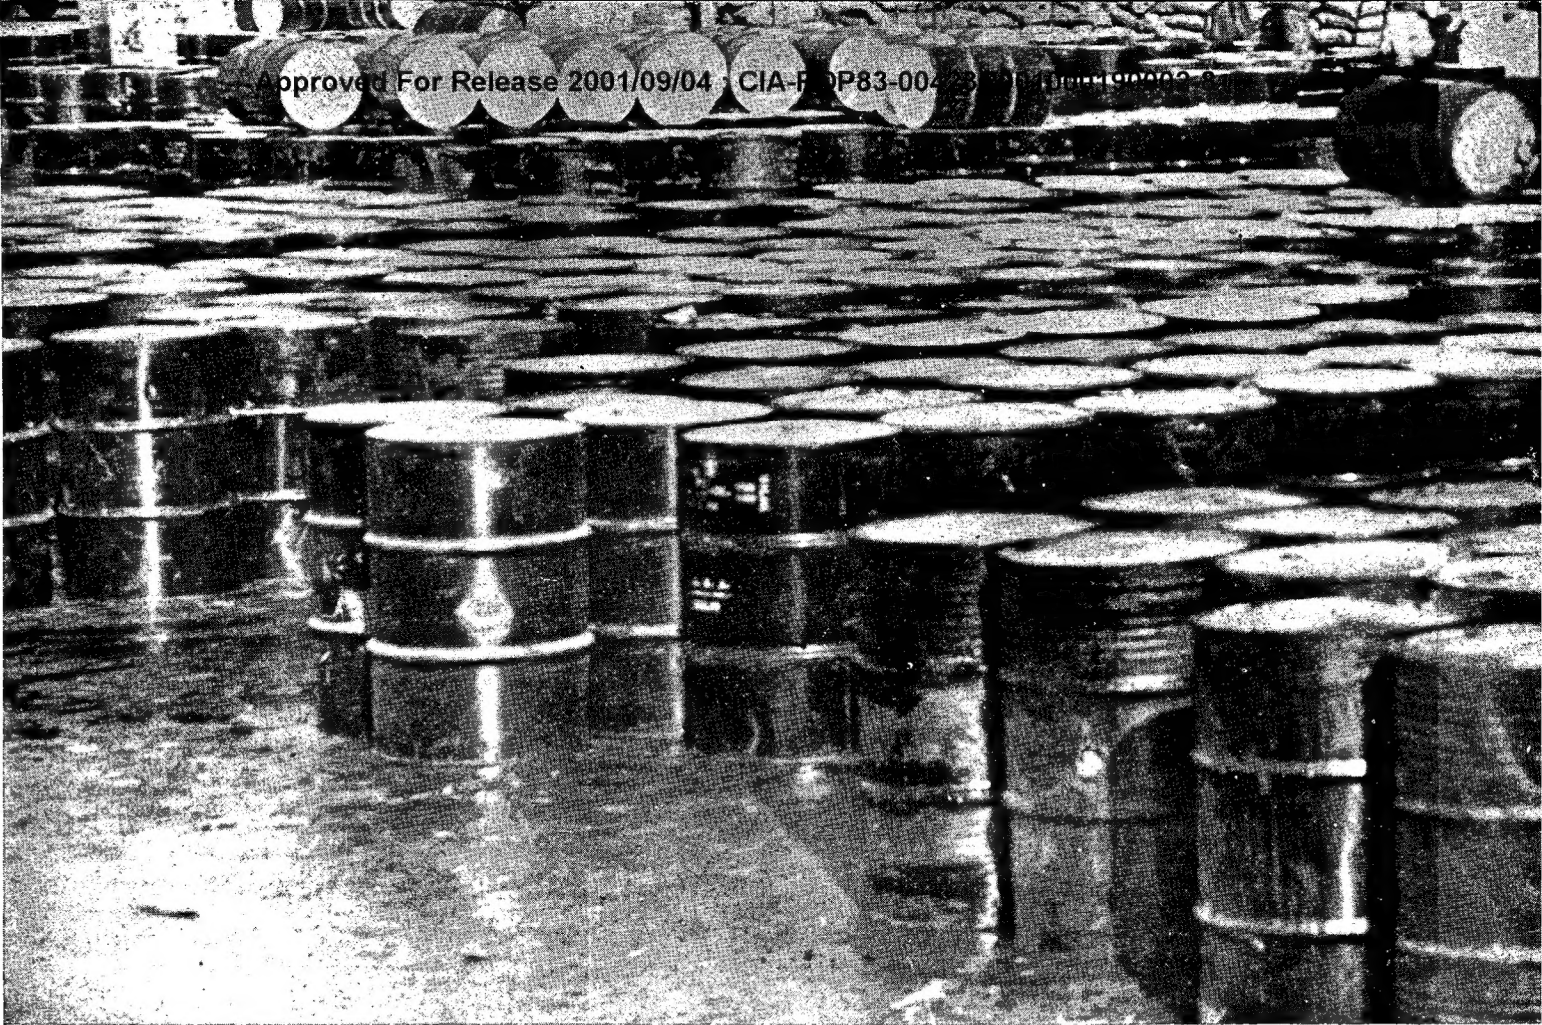
Before: Fire Hazards: Storage of drummed petroleum products and general cargo in an oily lake.

After: Drummed petroleum products segregated by lot and stored in an isolated area.

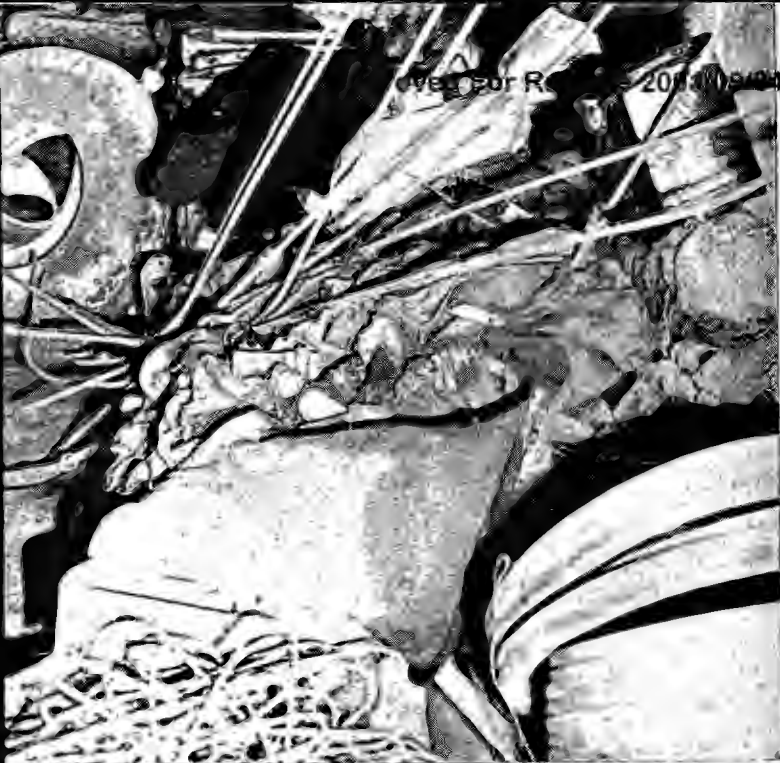
Before: Accumulations of junk and abandoned cargo in warehouses, August 1951.

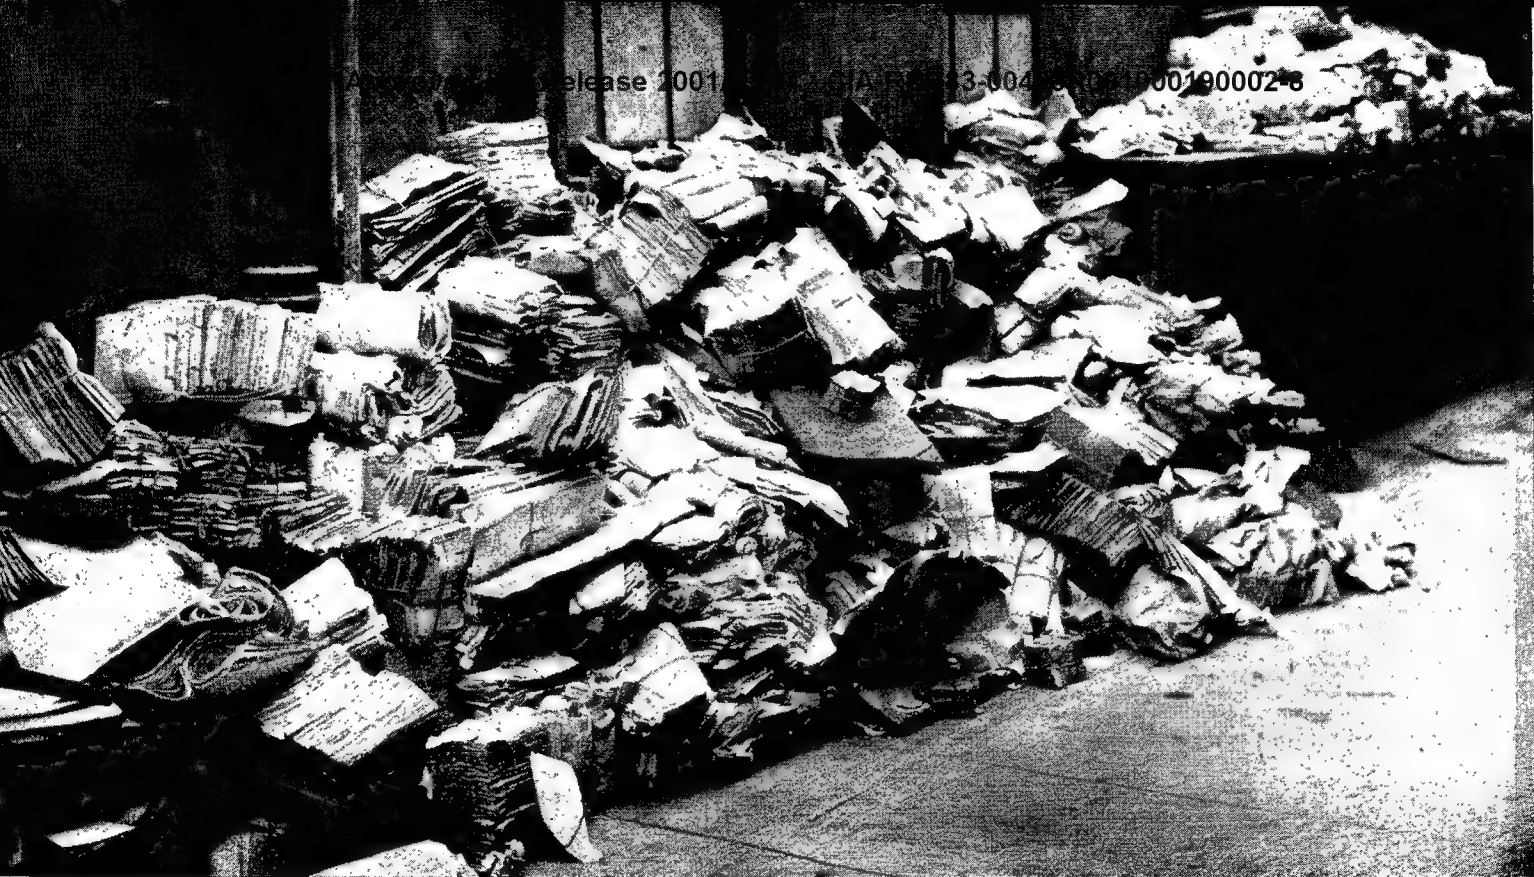
Before: Storage of official documents outside of main offices, May 1952.

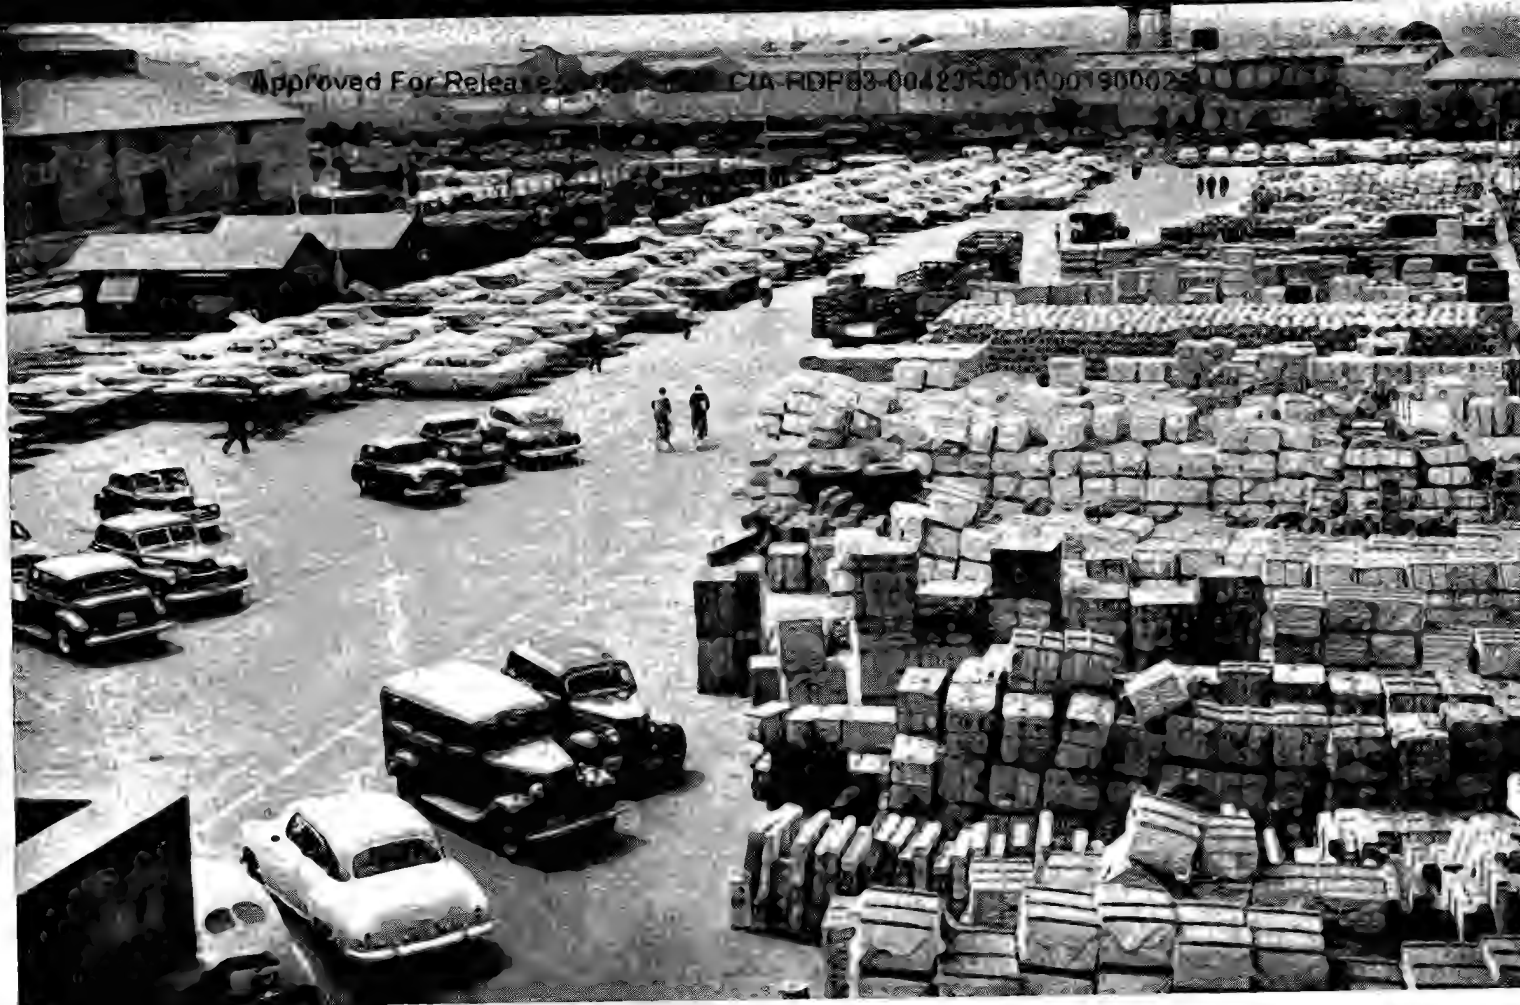
Before: Port congestion, cargo stacked in vehicle parking place, May 1952.

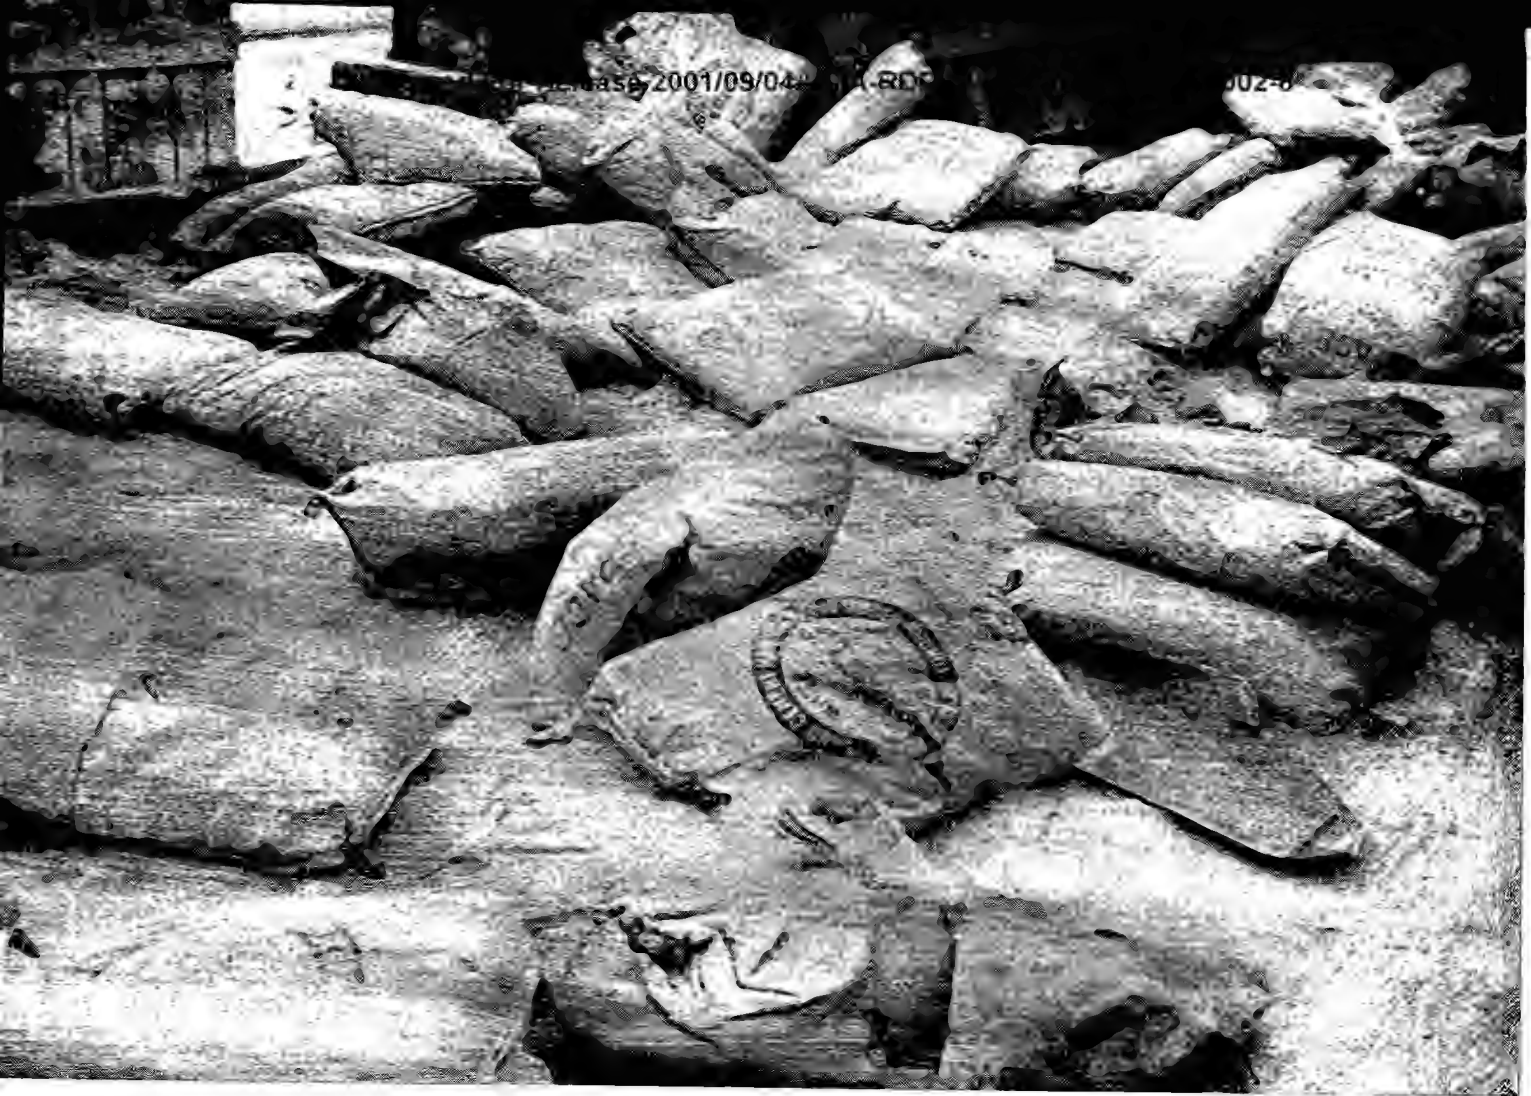
Before: Mishandled shipment of cement bags.

After: Handling of cement bags by pallets.

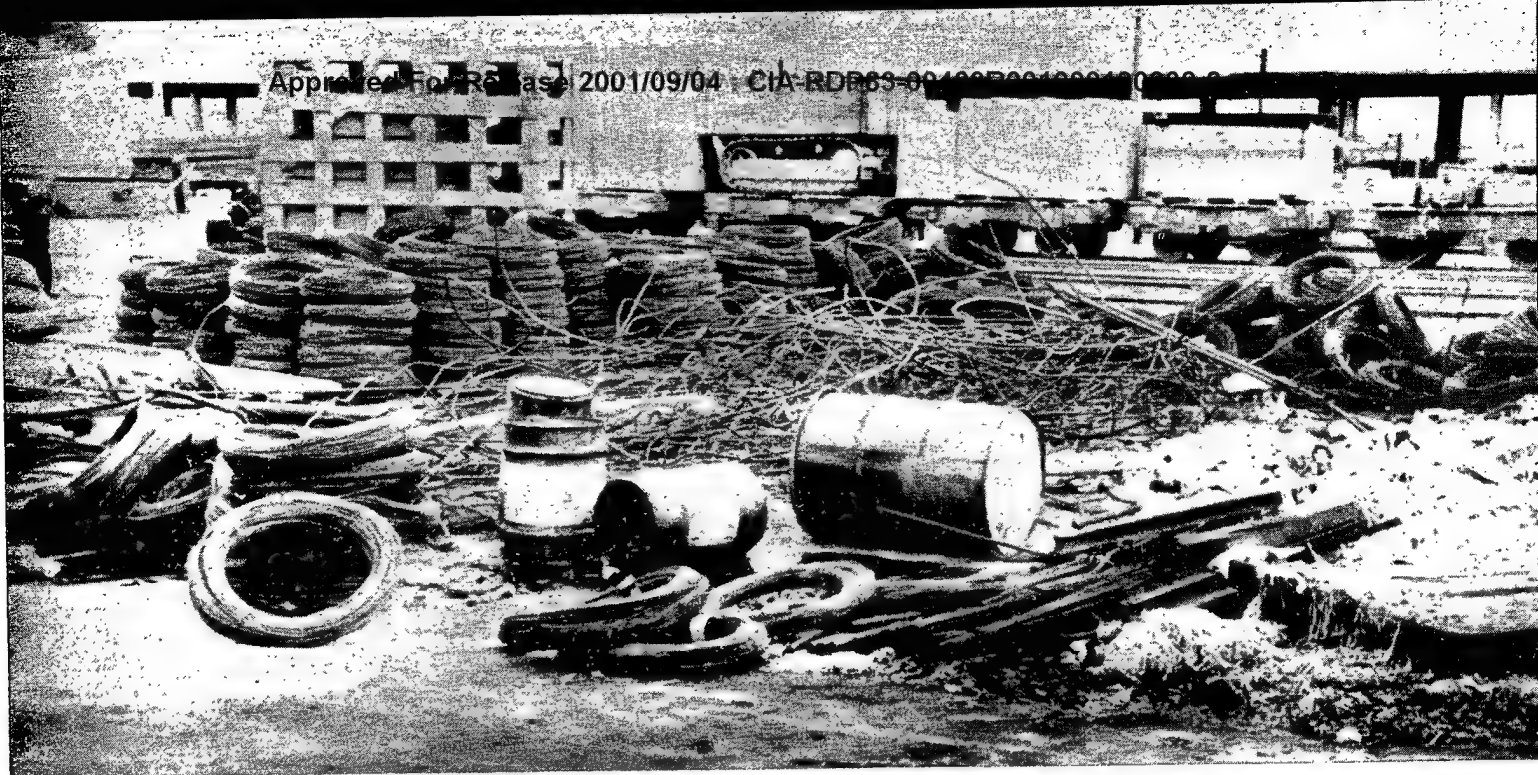
Before: View of cargo mishandled.

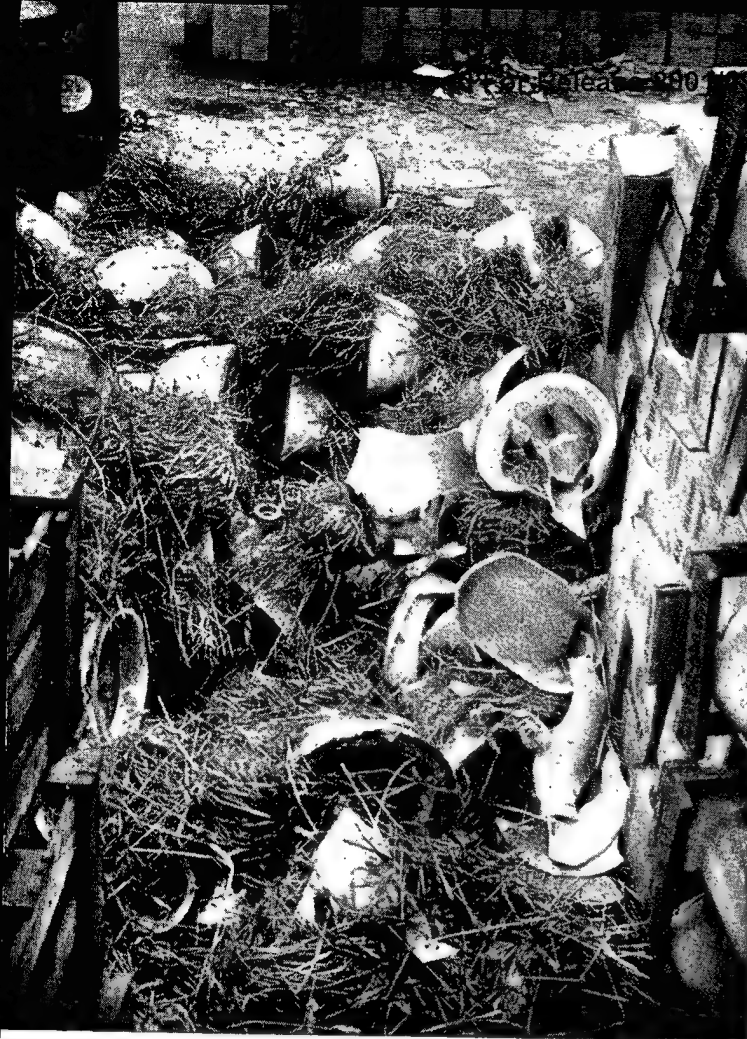
Before: View of cargo mishandled.

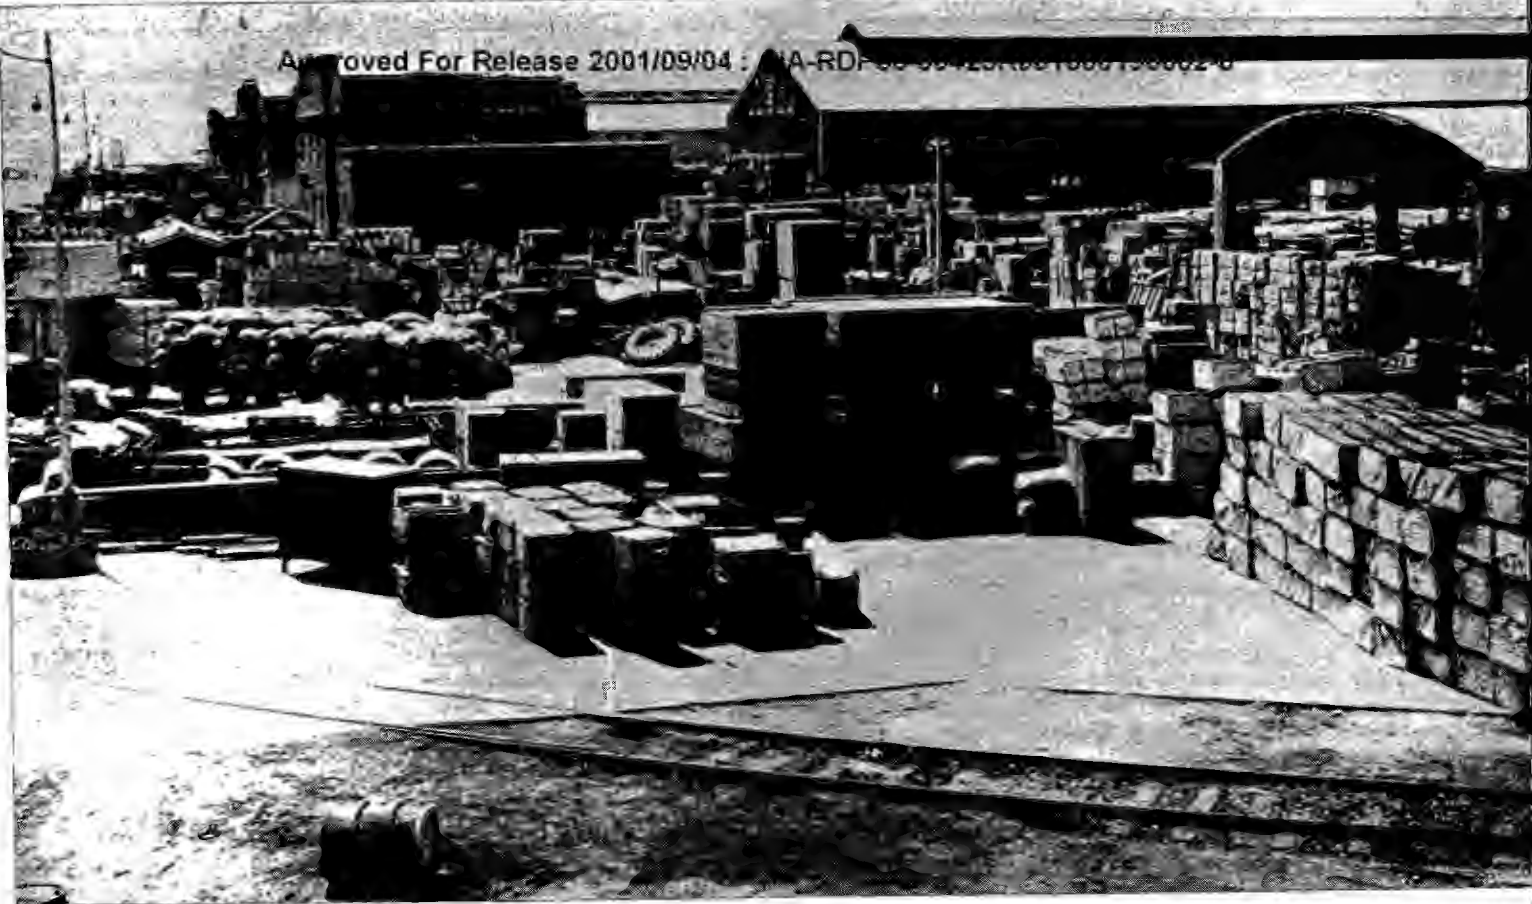
Before: Congestion in front of Main Buildings.

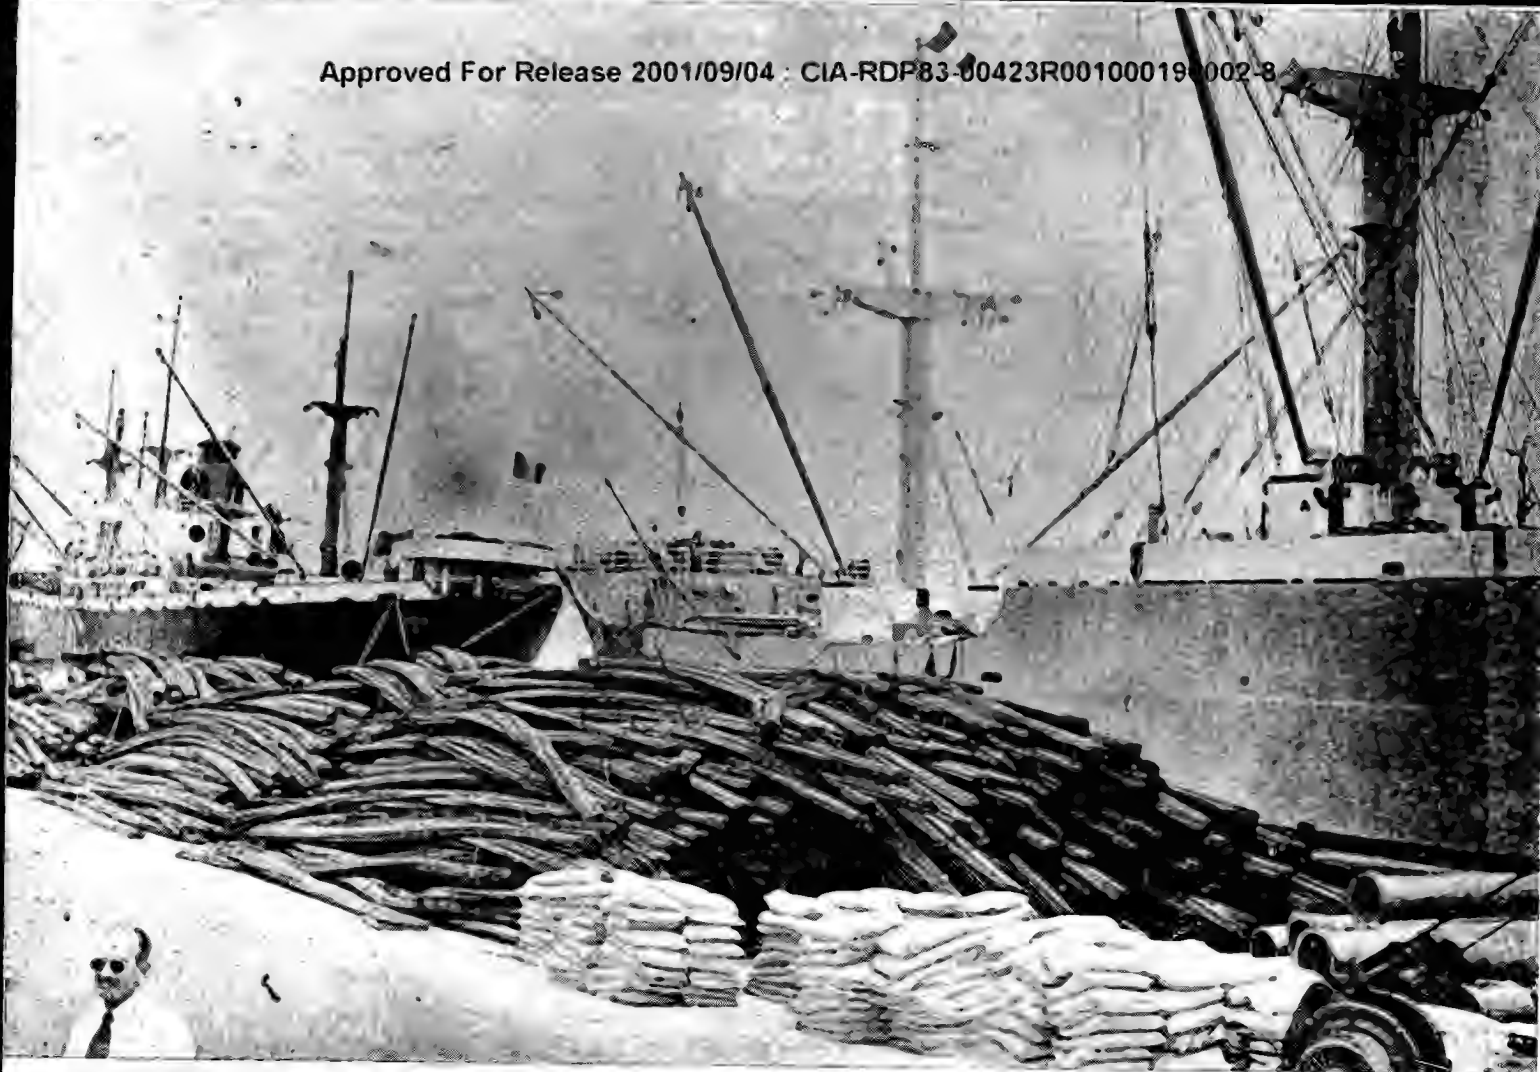
Before: Congestion on Long Wharf.

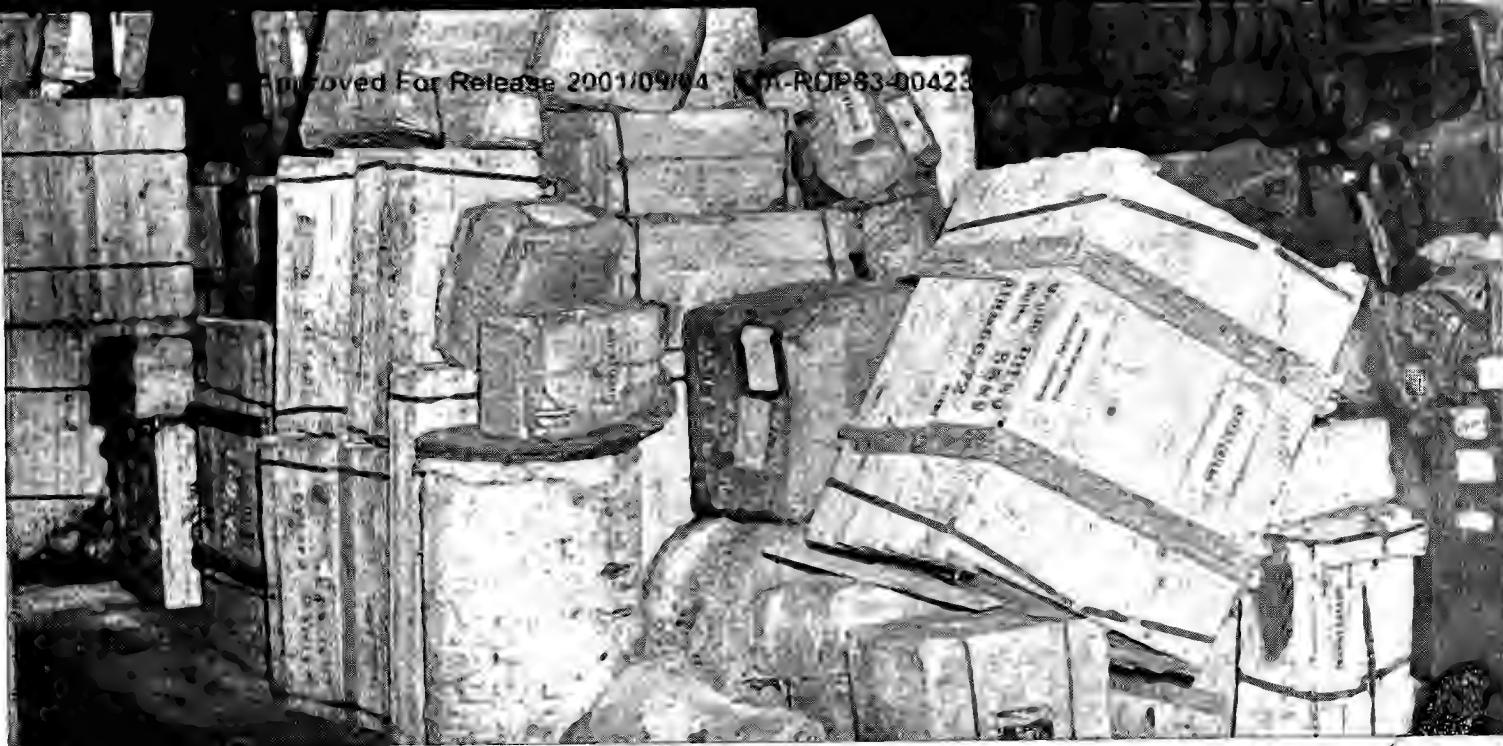
Before: Warehouse Operations. Cargo manhandled with considerable cargo damage and poor utilization of available storage space. In this type of operation it was difficult, if not impossible, to locate a given shipment.

After: Warehouse Operations. Use of the Pallet Rack System and Mechanical Handling. This type of operation is speedy and reduces cargo damage as well as facilitating location of cargo.

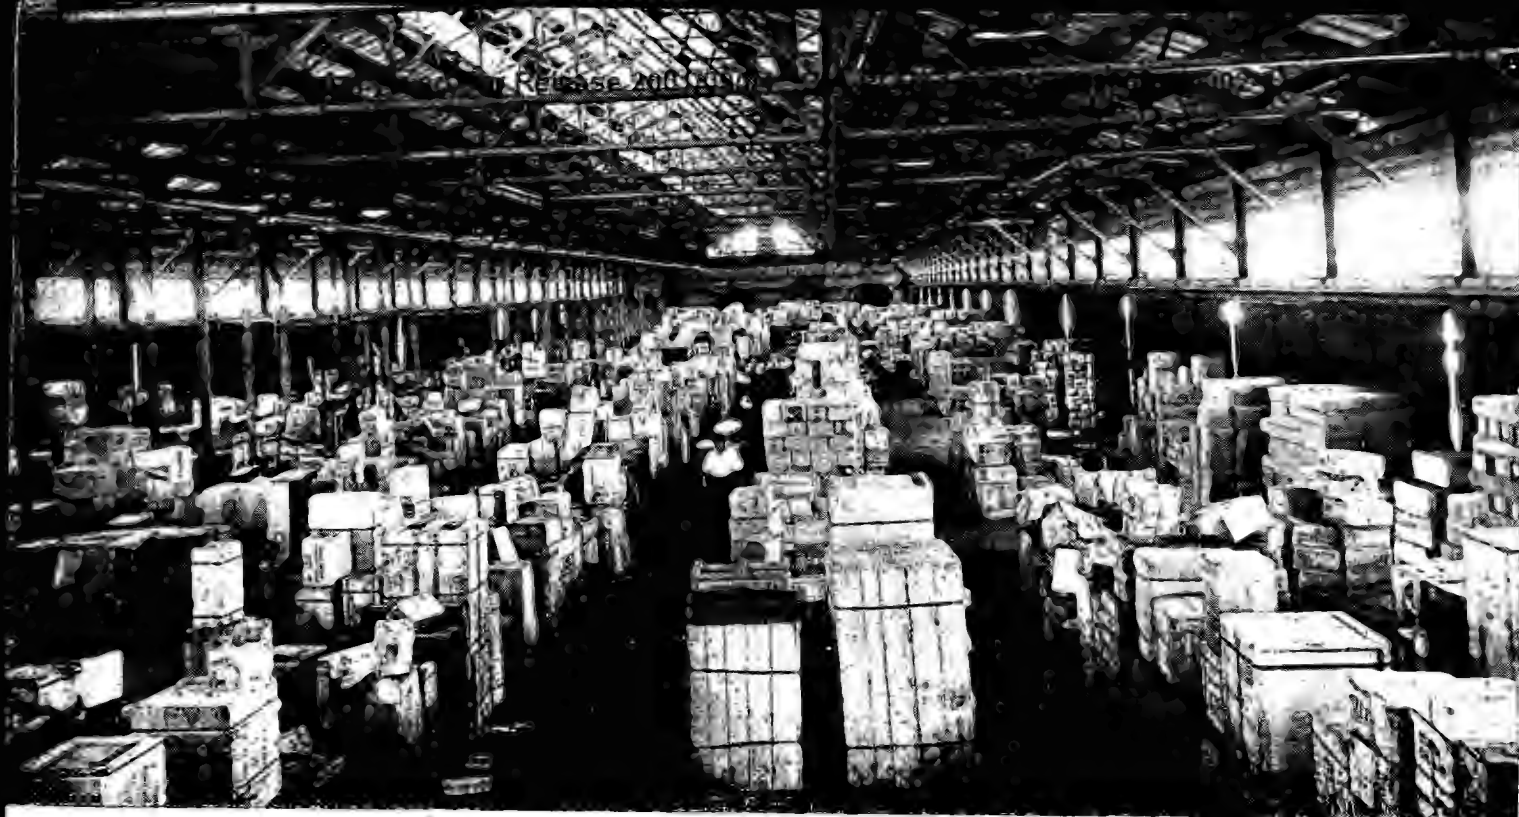
Before: Warehouse Operations. Poor space utilization — Manhandling — Cargo Damage — Impossible to locate given shipment.

After: The modern Pallet Rack System, giving excellent space utilization for small lots and general cargo (Retail Phase of the Operation). Palletized large lots are stored in the open area at the far end of the warehouse. (Wholesale Phase of the Operation).
